Bitumen membrane refurbishment and protection based on the HYPERDESMO® System

The exposure of old bitumen membranes to intense elements such as fluctuating temperatures, UV radiation and rain, often results in their aging and inevitably the creation of leaks that lead to substrate corrosion. The HYPERDESMO® System offers a unique solution that allows to restore watertightness without having to remove the bitumen membranes.

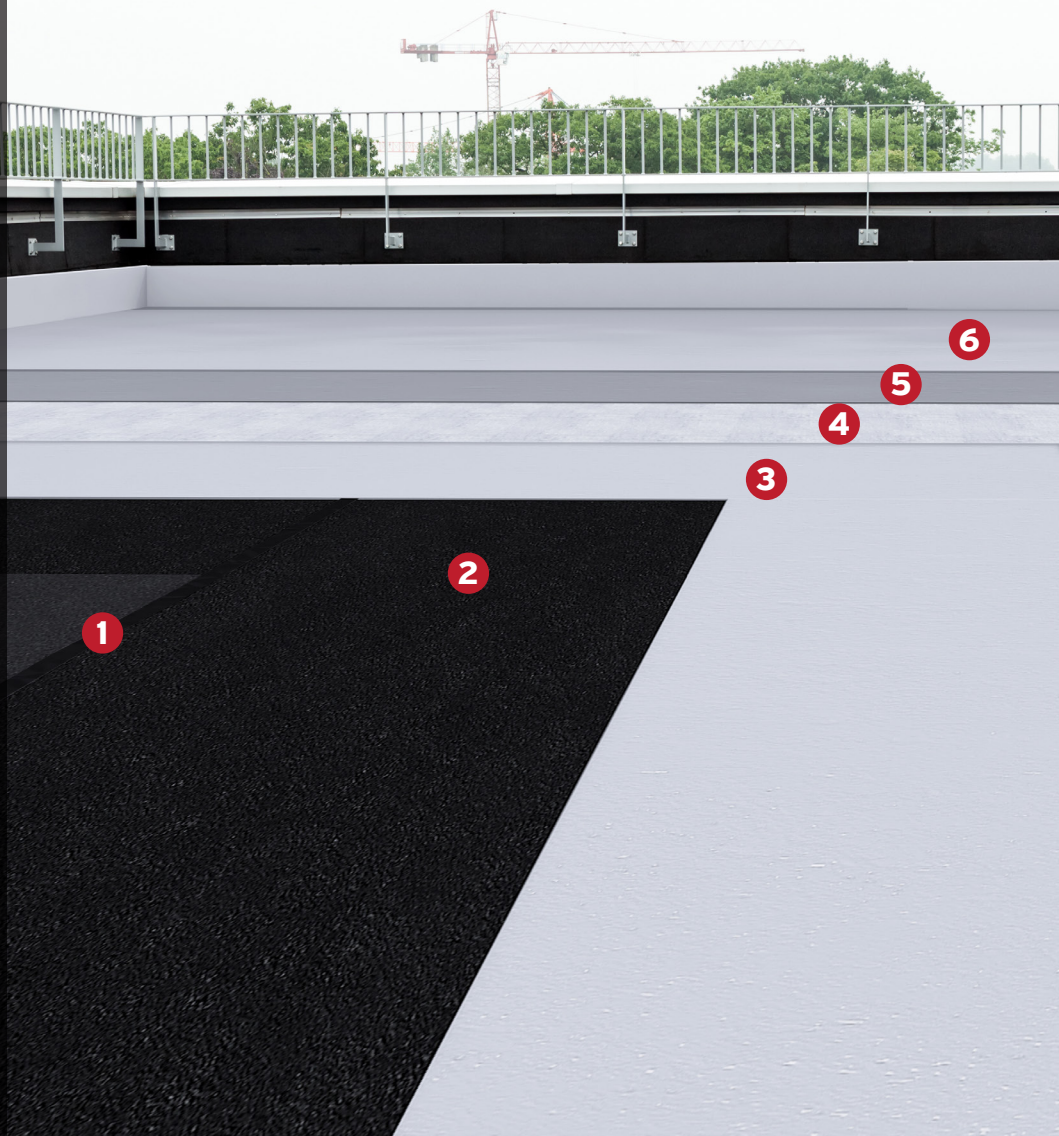
1 DETAILS TREATMENT & REPAIRS

2 PRIMING

3 WATERPROOFING (1st coat)

4 REINFORCEMENT WITH GEOTEXTILE

5 WATERPROOFING (2nd coat)

6 TOP COAT APPLICATION
